William Blackstone Log House
HO-724
3597 Centennial Lane
Ellicott City vicinity
ca. 1877
Private access until demolition

Maryland Inventory of Historic Properties Form

Inventory No. HO-724

historic William Blackstone Log House

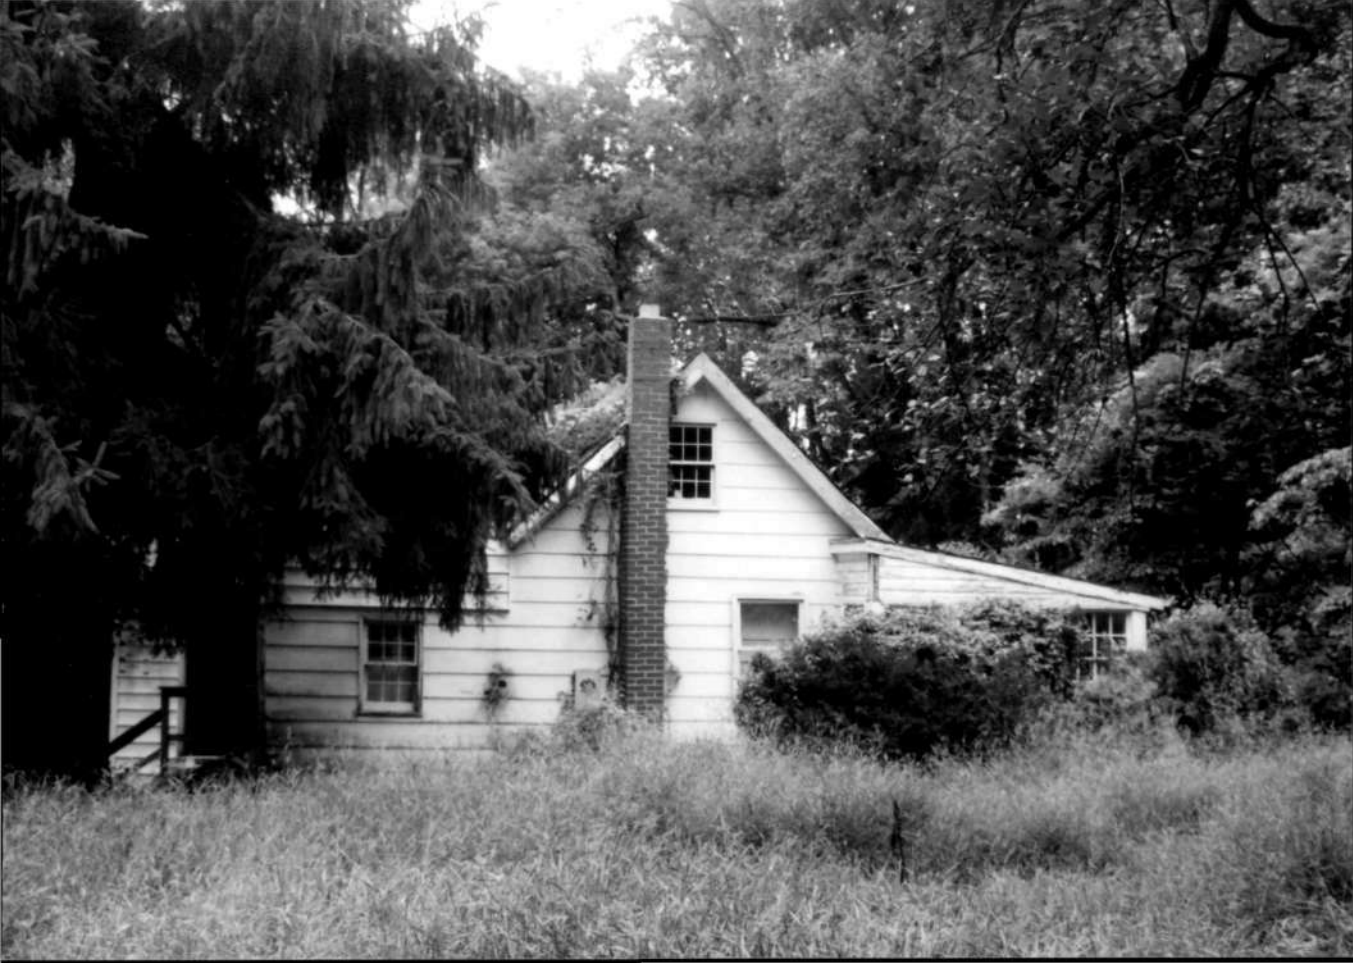
2 of 10

The circa-1877 log section in the center of the house measures approximately 17 feet 4 inches by 11 feet 4 inches. It rises one-and-one-half stories with a gable roof and a fieldstone cellar underneath. The gable ends have plain fascia. The log section is covered in 10-1/2 inch wood siding, and the log corner joints are not visible. The north gable end contains a first-story 1/1 sash window, offset to the west of center, and a 6/6 sash window in the center of the gable. A twentieth-century brick exterior chimney is offset to the east of the gable window. Bricks that appear to be older than those in the present chimney are imbedded in the dirt surrounding this chimney. The south gable end of the log section contains a first-story 6/6 sash window that is offset to the west of center, a 6/6 sash window in the center of the gable, and a centrally located cellar door.

North facade

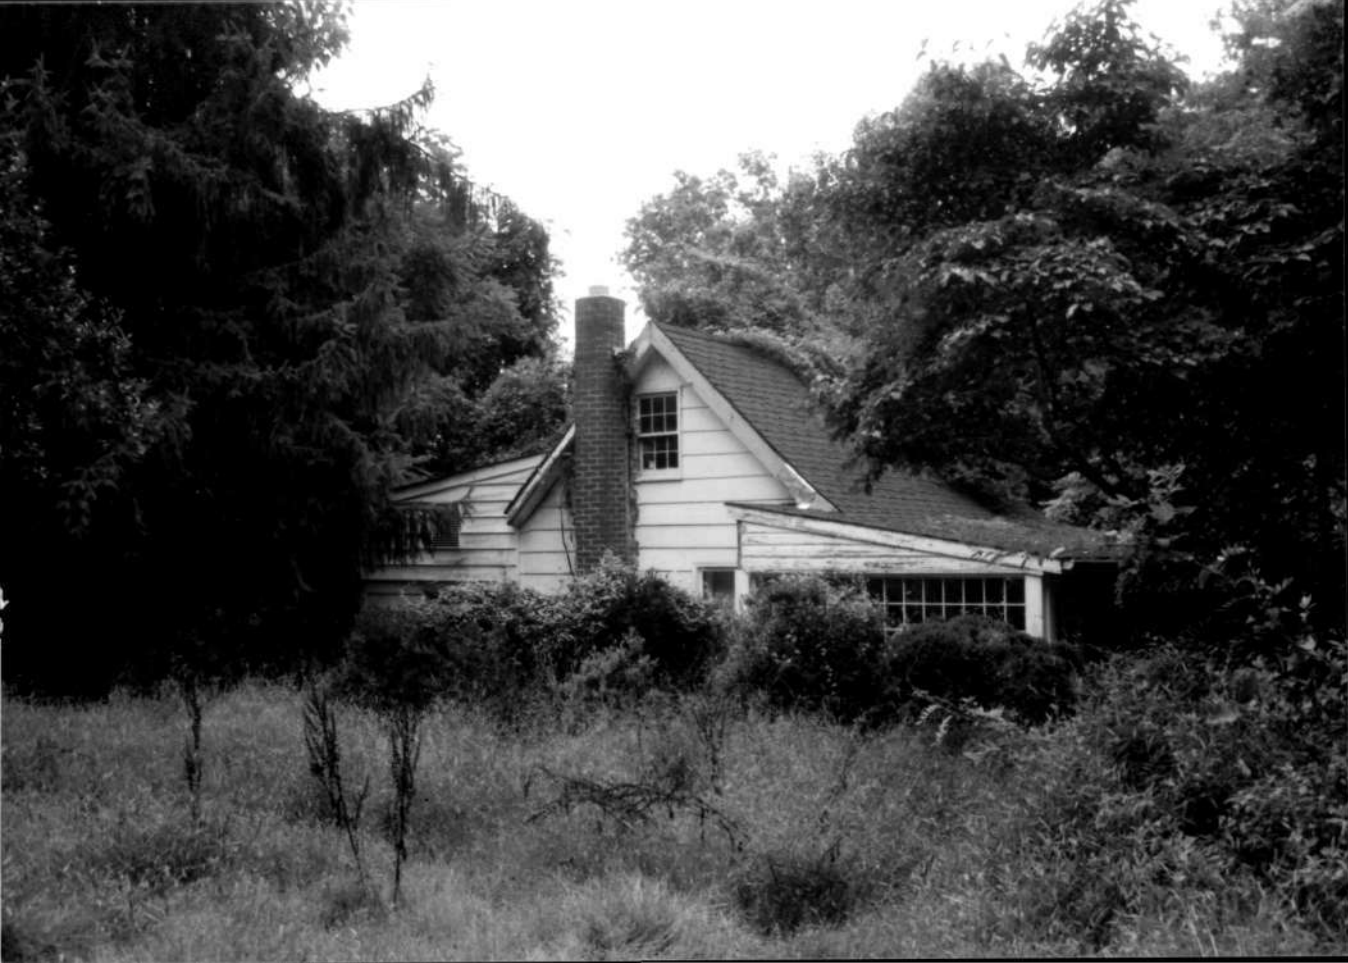
3 of 10

Three twentieth-century additions project from the log section. The evolution of these additions is not clear. A one-story addition extends to the front (west) of the log section. A concrete-block foundation indicates twentieth-century construction. The addition has a shed roof and a crawl space. The north corner of the addition is an enclosed porch that has a brick foundation on the north side and is clad in 3-3/4 inch German siding. The remainder of the addition has 3-inch German siding. The west façade of the addition has an exterior wooden door with eight panes over one horizontal panel. The door is located on the north end. Immediately inside this door is a wooden door with four panes over three horizontal panels. A pair of 9/9 sash windows with metal screens and a 6/6 sash window follow to the south of the door opening. The north façade of the front addition contains a large picture window divided into 84 panes. The east façade has one 9/9 sash window. The south façade of the front addition has one 6/6 sash window and a crawl space window opening.

NW corner

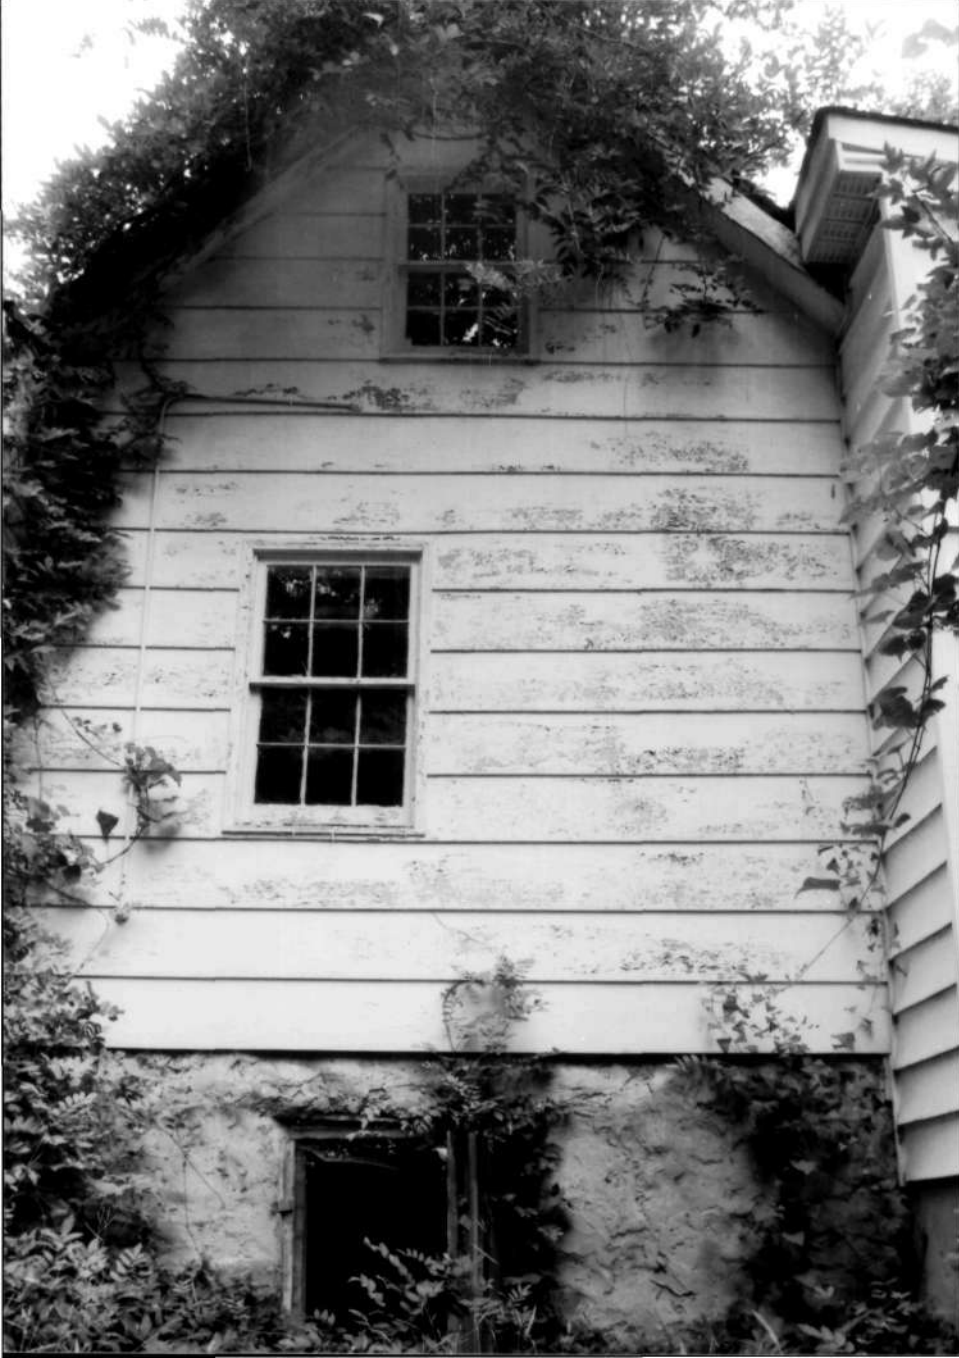
#4 of 10

Log section, south facade

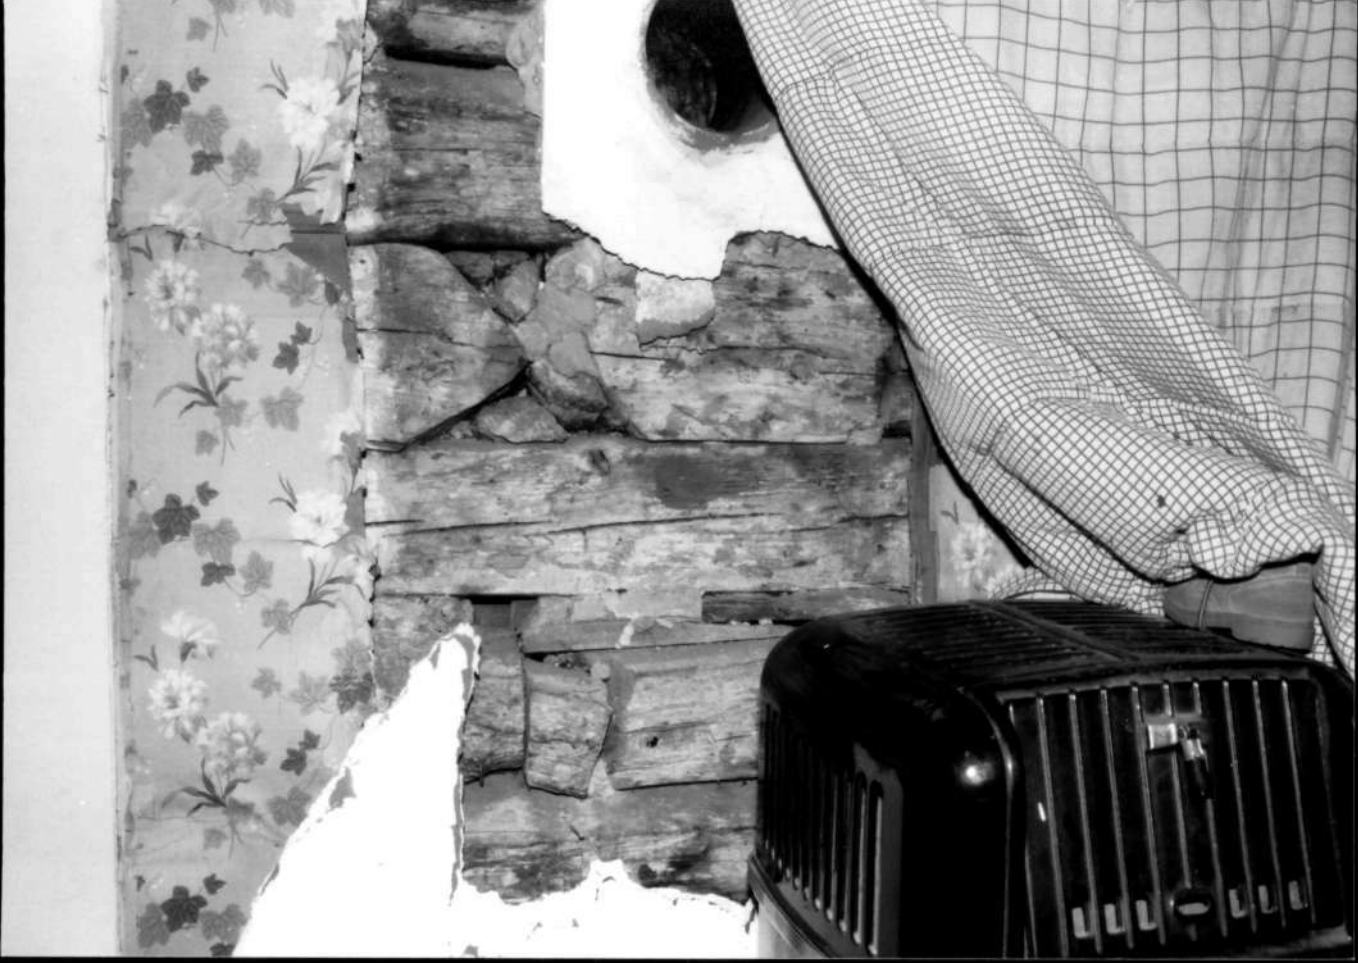
5 of 10

The interior of the log section consists of one room on the first floor with a loft above. The log walls are covered by wallboard; however, some of the board has been stripped, leaving the logs visible on the north and west walls. The logs measure 7 to 8 inches, are hewn on two sides, and are whitewashed. The gaps are filled with stone chinking. Animal hair is visible in the chinking on the north wall. Lath and plaster are not evident. At some point in time, the log walls were painted light blue and then white. Ceiling height measures 6 feet 10 inches. The ceiling is covered by wallboard; log joists, hewn top and bottom, are exposed. The joists measure 5 to 6 inches and run east to west, spaced 16 to 20 inches apart. The floor is covered with 11 to 12-inch planks that run north to south. A wooden staircase is attached to the south gable wall, east of the window opening. The staircase remains open on one side. There is no visible evidence of a fireplace or hearth, but there is a consistent break in the floorboards approximately one foot inside the north wall, running three-quarters the length of the wall beginning at the west end. A stovepipe opening connects to the chimney on the north gable wall. The west interior wall has a centrally located beaded batten door with a half cross buck. The door has strap hinges and a hook-and-eye latch that appears to be handmade. The east interior wall has a centrally located door opening with no door presently hanging. The window opening on the south wall has plain trim and appears to overlay a former opening. The window on the east wall has beveled trim with a rounded outer edge.

North log wall

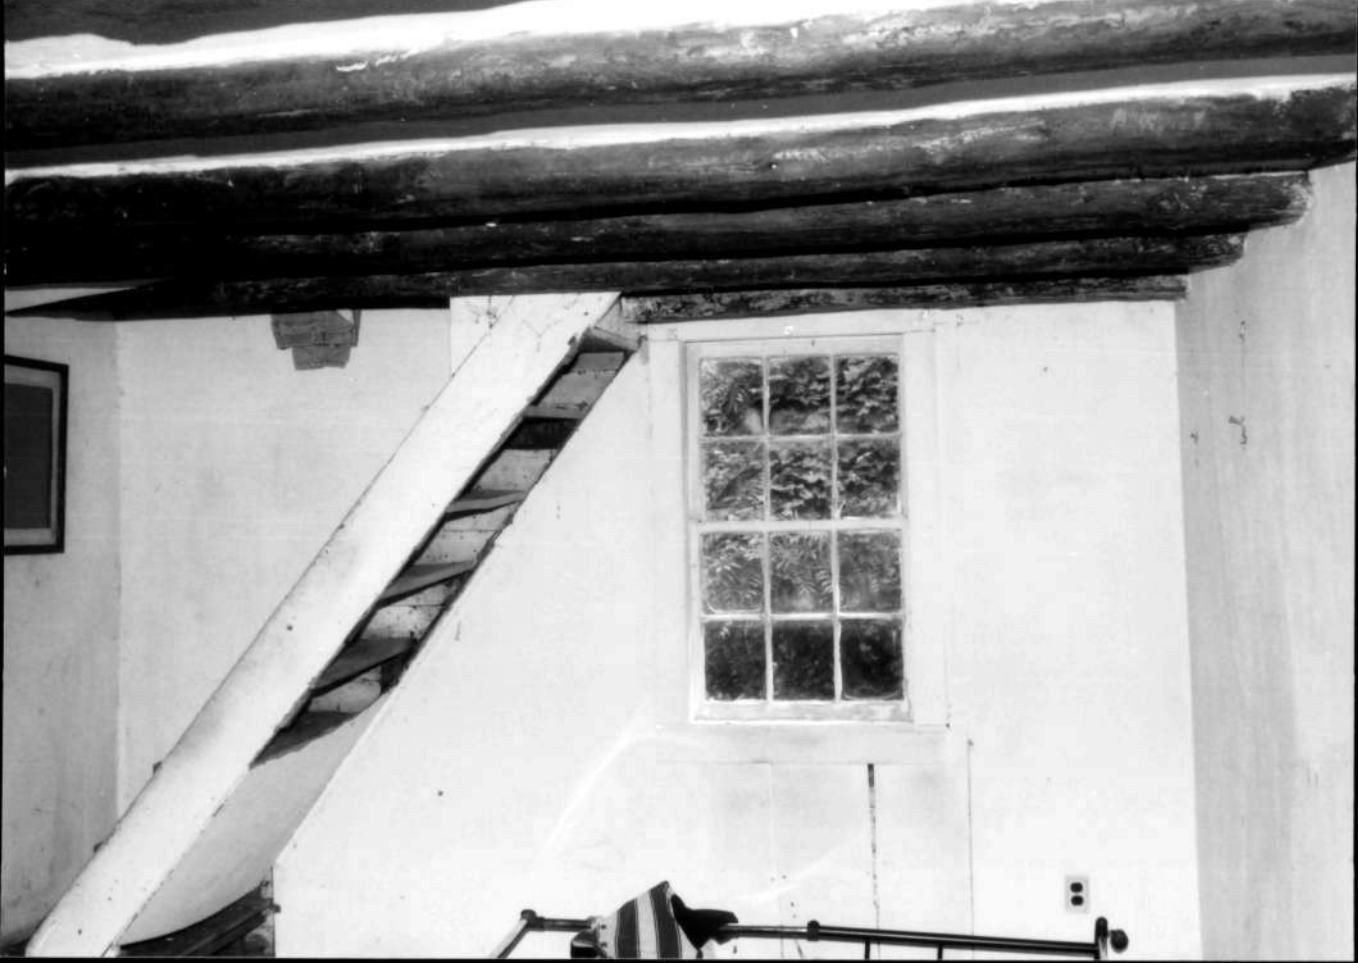
6 of 10

The house appears to be structurally sound. The interior is in fair condition. Wall covering has been partially removed, and the loft stairs are not sturdy.

Log ceiling joists, staircase, & south wall

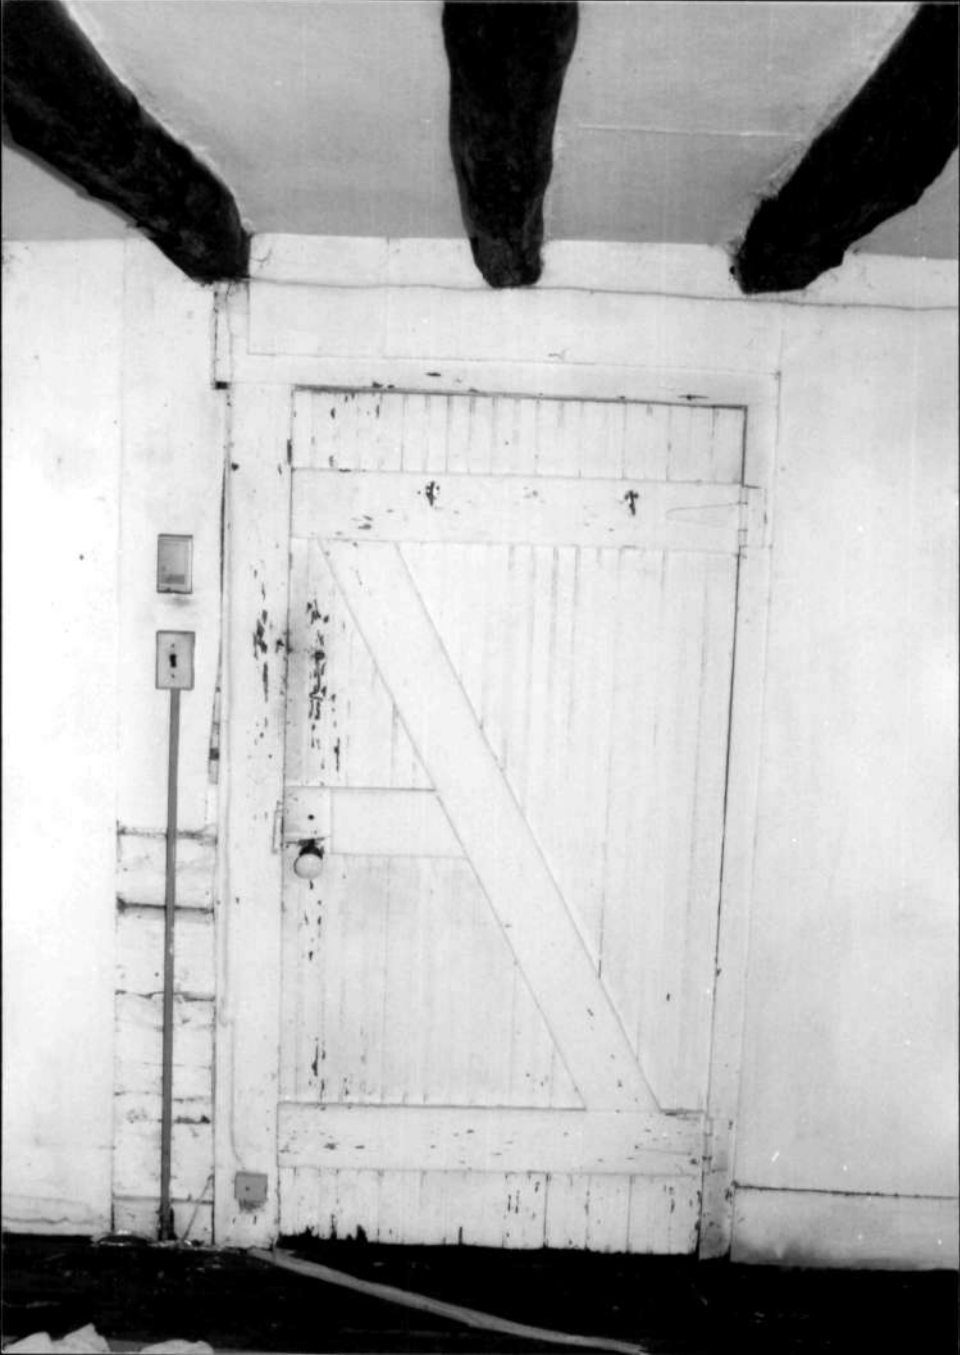
7 of 10

Beaded batten door + exposed
logs, west wall; log
ceiling joists

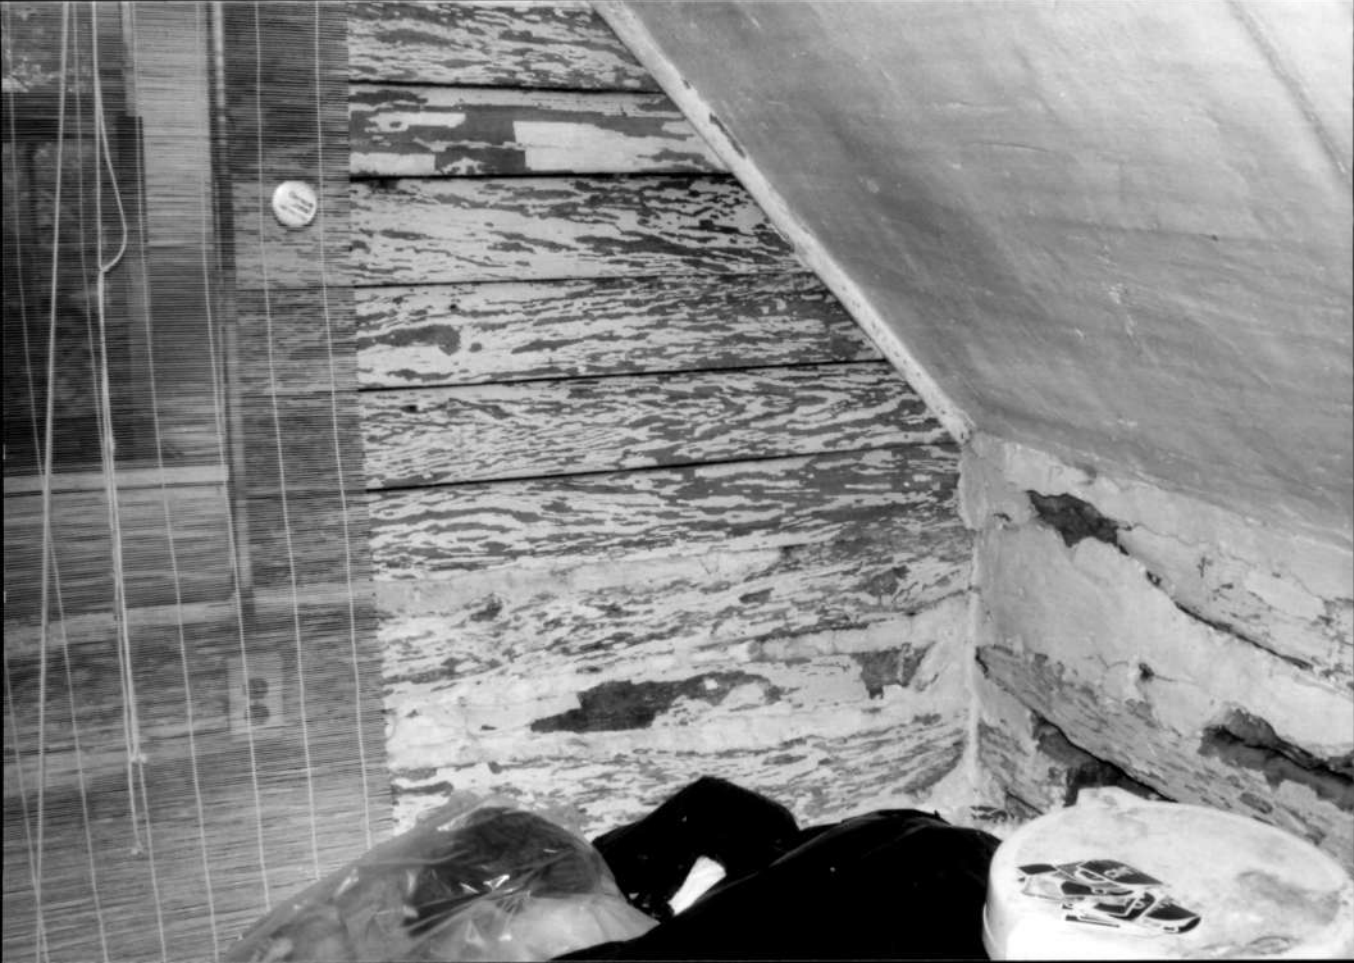
#8 of 10

The loft of the log section consists of two rooms divided by a partition wall running east to west and containing a central door opening. Whitewashed log walls rise through the loft until reaching the gables. The gable ends consist of 5-1/2 inch horizontal boards. Saw marks are not evident on these boards. The interior loft walls and ceiling are covered in a combination of wallboard and plaster. The partition wall is covered in plaster applied to horizontal, circular-sawn lath, indicating that the wall was constructed or finished after 1850; animal hair is present in the plaster. Ceiling height at the roof ridge measures 6 feet 7 inches. Rafters are not visible, but widely spaced roof decking boards can be seen through the north gable wall, suggesting a former wood shingle roof.

Loft, SW corner

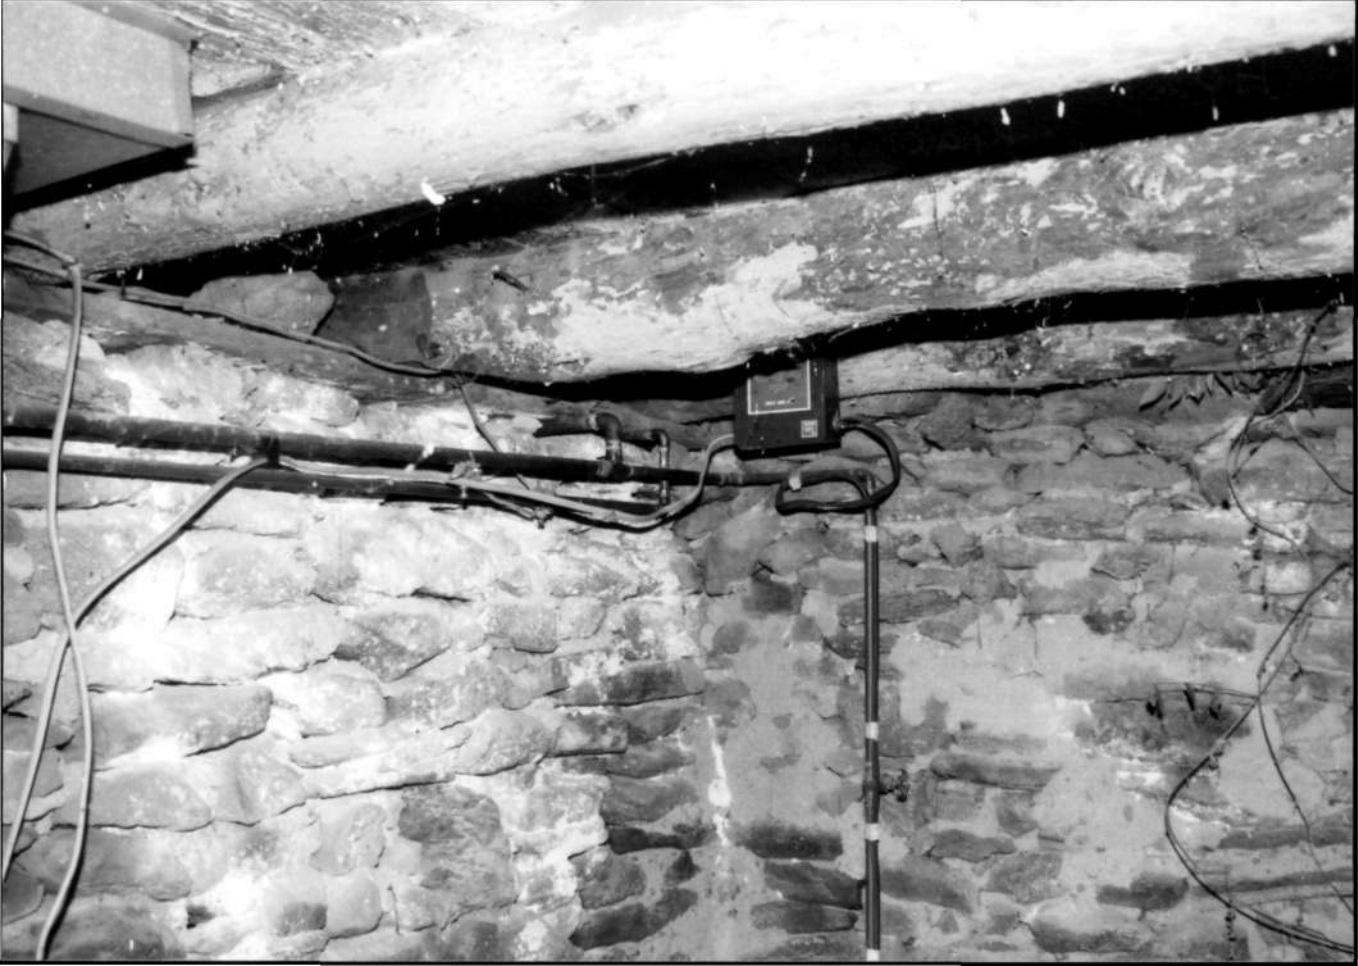
#9 of 10

The cellar of the log section has random-rubble fieldstone walls and a dirt floor. Joists consist of 6 to 7-inch diameter half-round timbers with bark. The joists run north to south and are spaced 12 to 16 inches apart. The joists rest on a 1-inch thick wooden sill. The undersides of the floorboards are circular sawn, indicating installation after 1850.

Cellar, SE corner

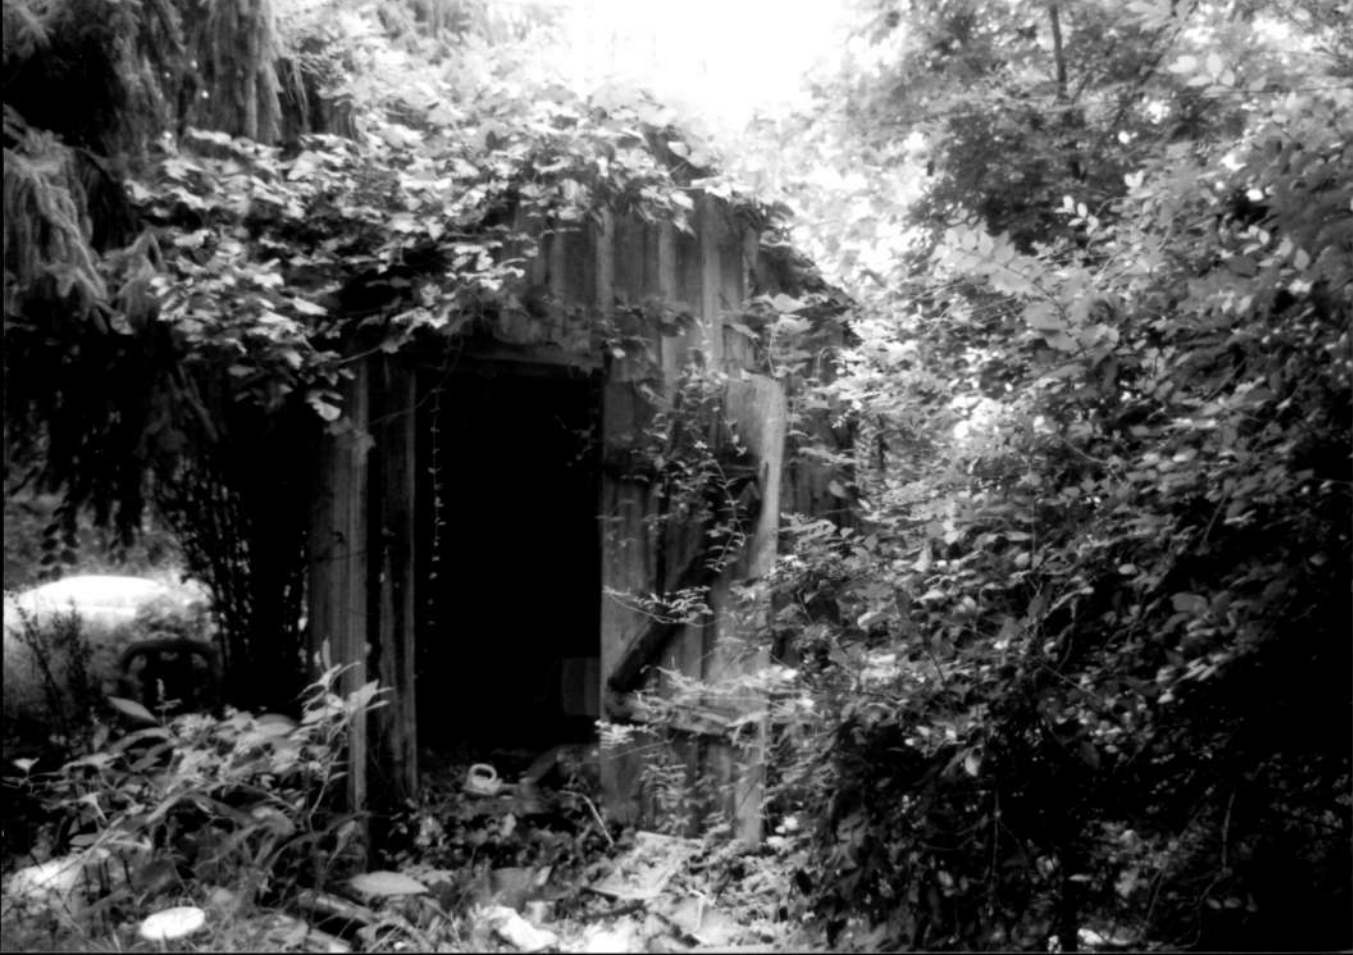
10 of 10

The small shed faces south. It has a front gable roof and a fieldstone foundation. The shed is clad in board-and-batten siding that is circular sawn. The roof rafters meet at the ridge with no pins. Roof structural members are sawn with the exception of two small logs that stretch from the east plate to the west plate. Composition shingles cover the roof. Wide spacing between the roof decking boards suggests a former wood shingle roof. A batten door with a half cross buck exists on the south gable end. No windows are present. Construction details and the approximate date of the log house suggest that the shed was built in the last quarter of the nineteenth century.

Small outbuilding, south facade
